Manhole Inspection Summary

Manhole # S41II_004MH

Insp Date: **6/22/09 2:08 PM**

Location Address: **FEDERAL ST**

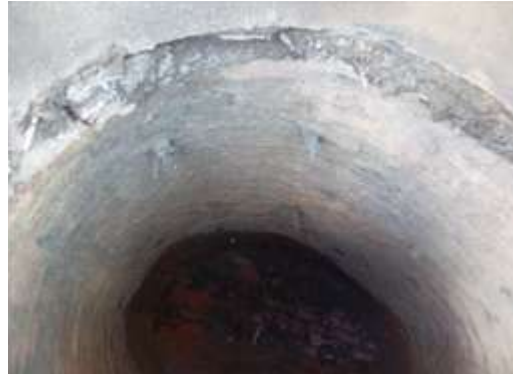
Defect 1

Condition: ☐ Sound ☐ Cracked ☐ Root Intrusion ☐ Loose Brick ☒ **Deteriorated**

Count: **4** Missing: **4** ☒ **Corroded**

MISSING STEPS AND CHIMNEY
DETERIORATED

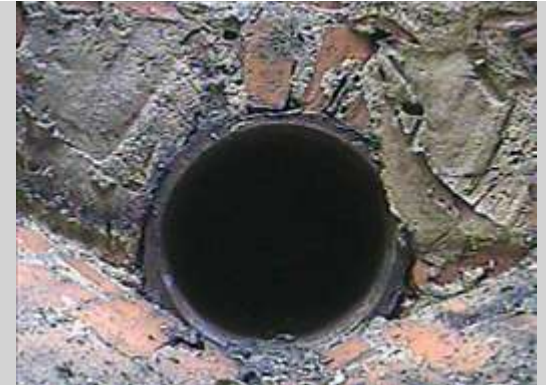
12 O'Clock Outflow

8 in. Circular Gravity Sewer
Pipe Out @ 12 O'Clock

Infiltration: **None** Pipe Seal Cond: **Sound**
